# Muntz Marine Surveyors

## SAMPLE Condition and Valuation Report

1993 Beneteau Oceanis 510  
named

Date of Report: April 5, 2006

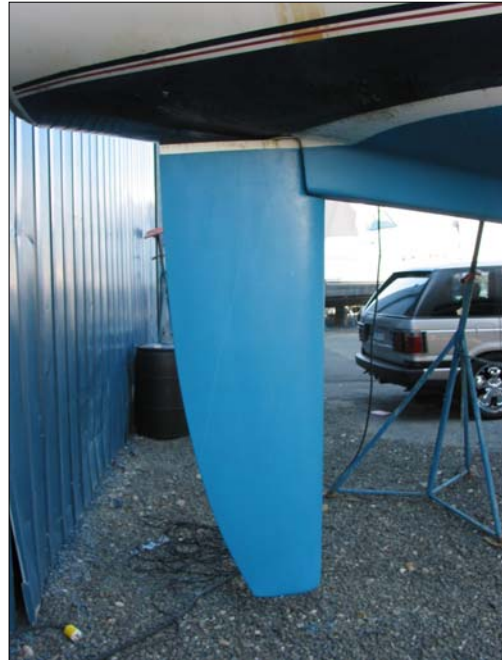
The exterior of the rudder was smooth and fair, no weeping or swelling was noted. It rotated easily without binding and there was no play between the rudder stock and its bearing or between the rudder blade and the rudder stock.

Moisture meter readings were moderately elevated (up to 228).

The steering cable was free of broken strands where visible and its tension was adequate. The bulldog grips were properly installed. The cable was in need of lubrication.

***Recommendation:*** Monitor the rudder for delamination or movement of the blade in relation to the rudder stock at each haul out. Consideration should be given to drill a small hole near the bottom of the rudder in the fall in order to drain any water that might have accumulated, thus preventing frozen water to split the rudder.\*

***Recommendation:*** Lubricate the steering cable with oil (not grease).\*

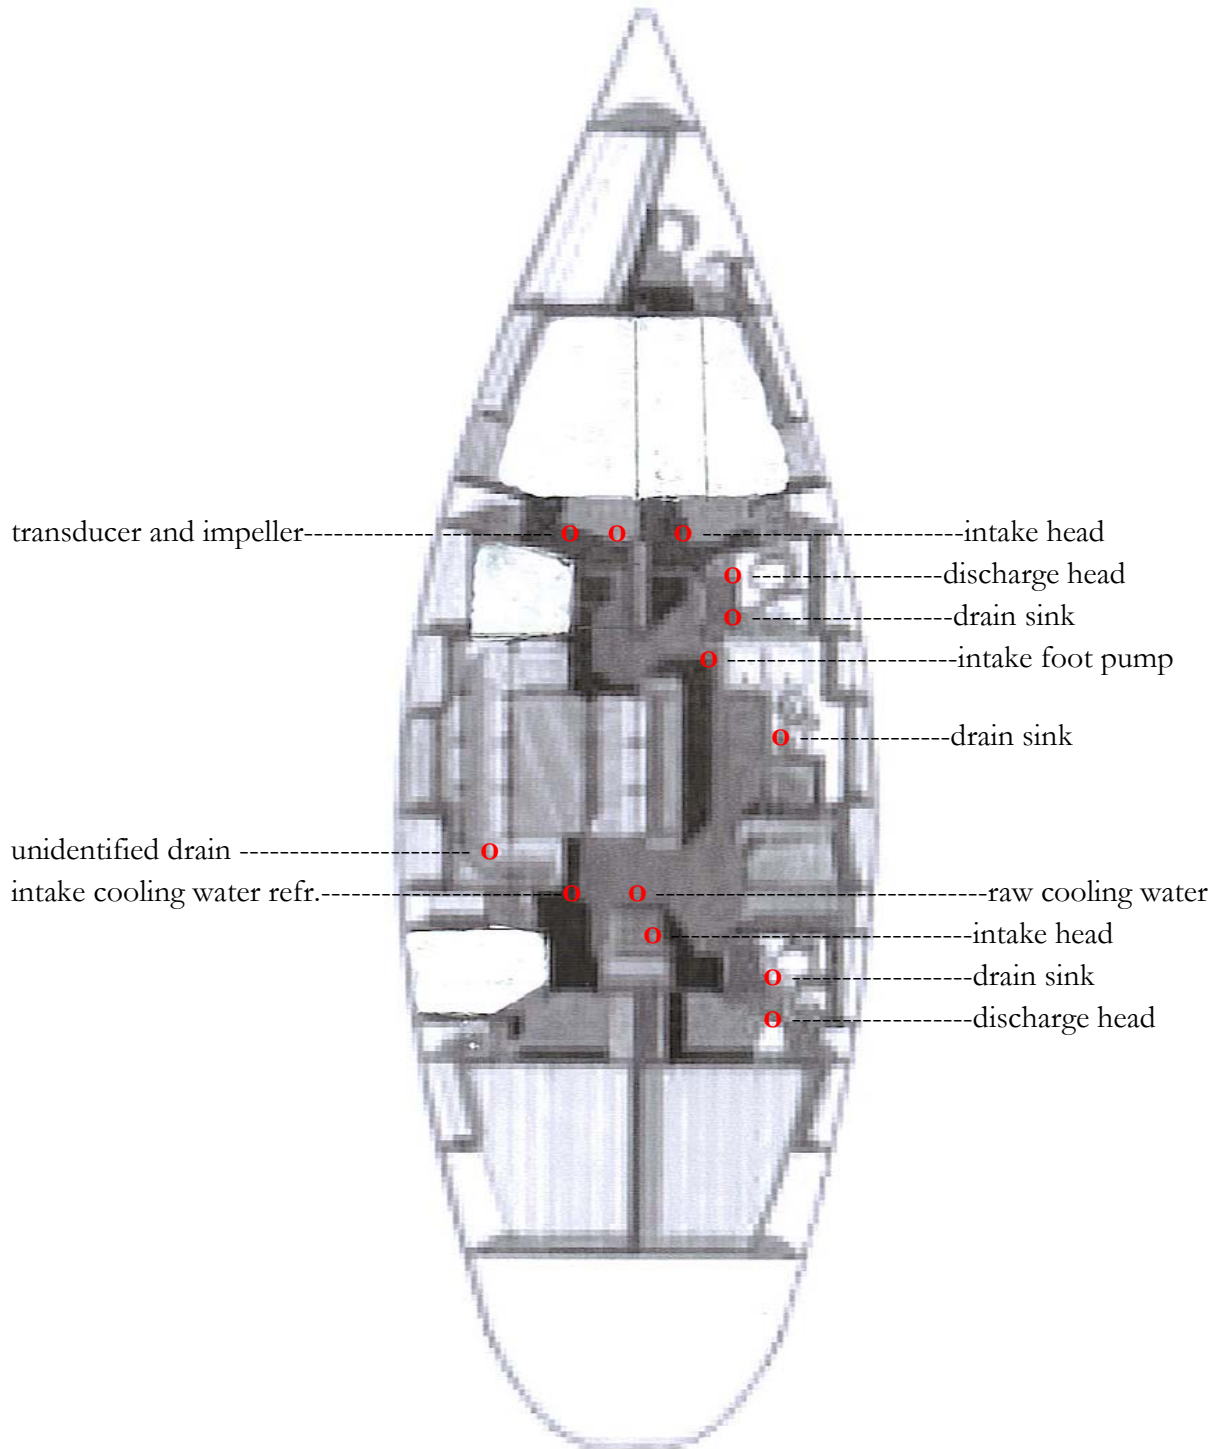
**Appendix D**  
**Schematic Location of Below-Waterline Thru-Hulls**

All thru-hulls, seacocks and hoses were in good condition as seen.

The exact composition of the alloy of the seacocks was unknown, but it may be galvanically incompatible with the bronze through-hulls, which may lead to catastrophic failure of the seacock or through-hull.

***Recommendation:*** Remove some of the seacocks from their through-hull fittings and check both for galvanic corrosion. Replace all seacocks if galvanic corrosion is found.\*\*
