Marine Survey Report

1999 Maxum 4100 SCA Aft Cabin
named

Date of Report: May 8, 2003

Date of Survey: May 2, 2003

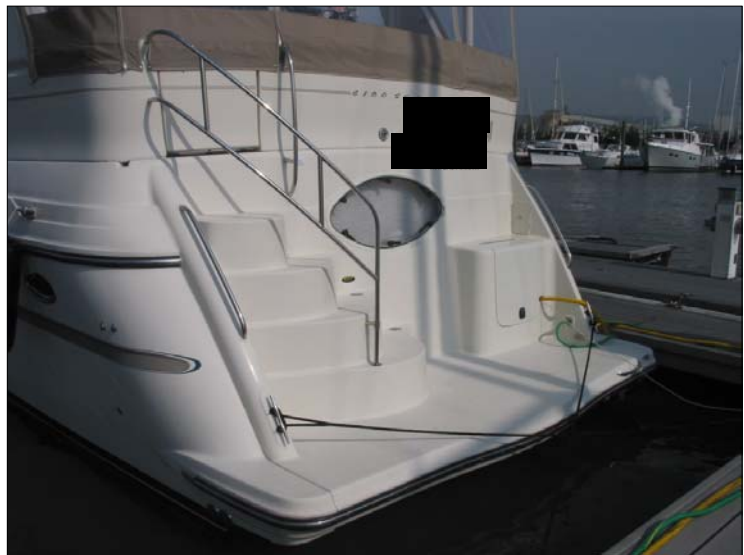
Transom and integrated swim platform

The finish of topsides and decks was the original gelcoat, and was in excellent cosmetic condition.

The topsides, decks and bottom were sounded, at random, with a light phenolic hammer for evidence of hollow or dull areas in the lay up and none were observed.

Moisture meter readings of hull and decks, randomly taken with a portable moisture meter, were unremarkable. Moisture meter readings of the bottom were not taken as the surface did not dry sufficiently during the haul out.

A careful visual examination of the bottom showed no evidence of osmotic blisters.

The anti-fouling paint, (reportedly Micron CSC), directly applied to the bottom without a barrier coat, was found to be in fair condition.

Recommendation: Consider to remove the anti-fouling and coat the bottom with a two-part epoxy sealer, such as the InterProtect Barrier Coat System as a barrier against blister-causing moisture and re-apply antifouling*

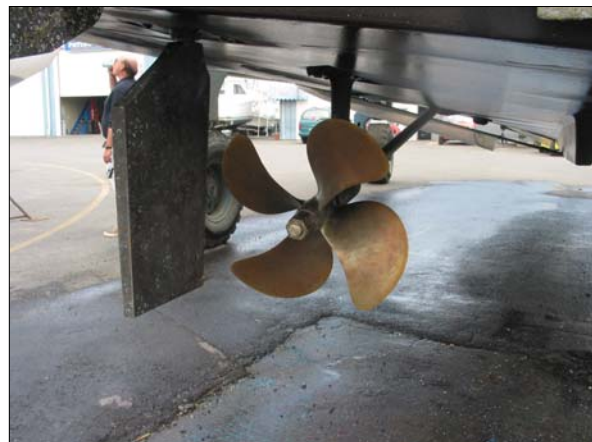
Portside rudder and propeller

The propellers showed no signs of corrosion and were free of nicks or other damage

They were snug to their shafts and properly secured by locking nuts and cotterpins. When rotating the propellers by hand, they rotated easily without binding.

The propeller shafts were free of pitting or corrosion.

Recommendation: *Renew zincs on both propeller shafts. Consider adding an additional zinc on each shaft**

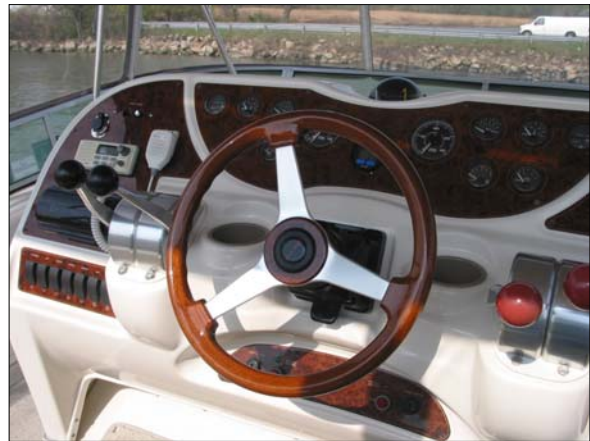
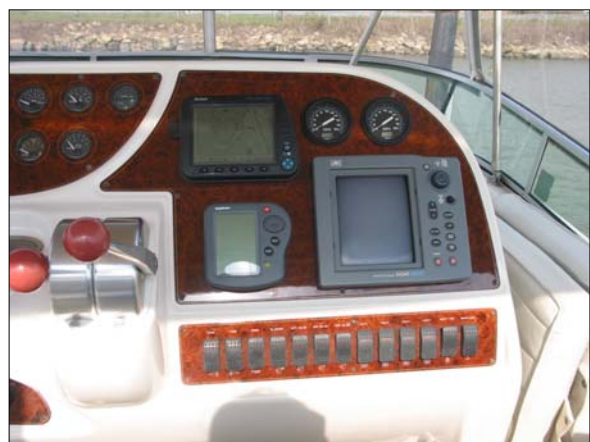
Operating station at flybridge

On the flybridge were installed an operating console, a vinyl upholstered operator's seat and a forward facing seat in front of the console. The upholstery was in excellent condition. A glass splash shield was installed in an aluminum frame which was in good condition.

The flybridge was enclosed by a bimini and canvas with acrylic windows, supported by stainless steel tubing.

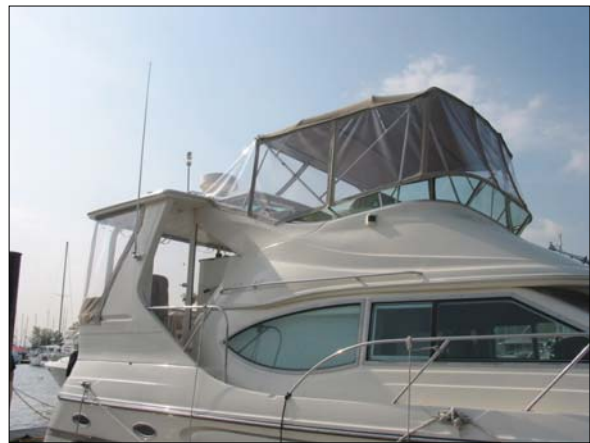
Gap in railing

Just ahead of the steps to the aft deck was a gap in the railing. Although grab rails were installed on the superstructure, the opening in the railing could present a hazard to someone going forward when the vessel is rolling at sea.

Recommendation: *Install a short stainless steel lifeline with pelican hook in the gap of the railing to port and starboard**

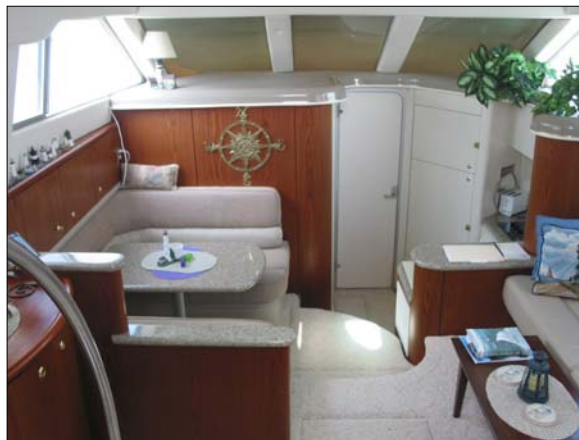
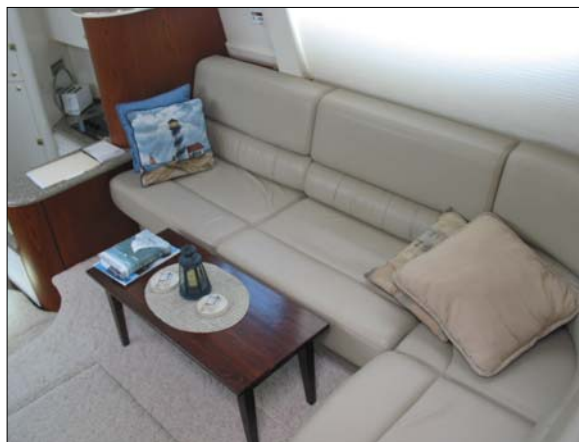
The interior was found to be in excellent cosmetic condition. Joiner work was cherry wood. The upholstery, bulkheads, lining and joiner work showed good care and maintenance. The floors were carpeted throughout the accommodation. In the galley was a parquet floor. The undersides of decks were vinyl lined. Sides were fabric lined. Drawers and locker doors were functional. Cabinet doors were provided with positive catches.

Main saloon looking forward and dinette

Main saloon convertible sofa

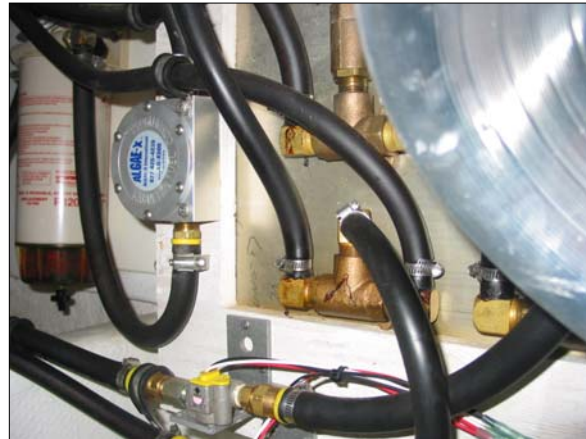
Fuel filters were free from signs of leaks at the connections; the collection bowls were clear.

A magnetic fuel conditioner type Algae-X was installed.

Fuel shut off valve, Racor filter and Algae-X system

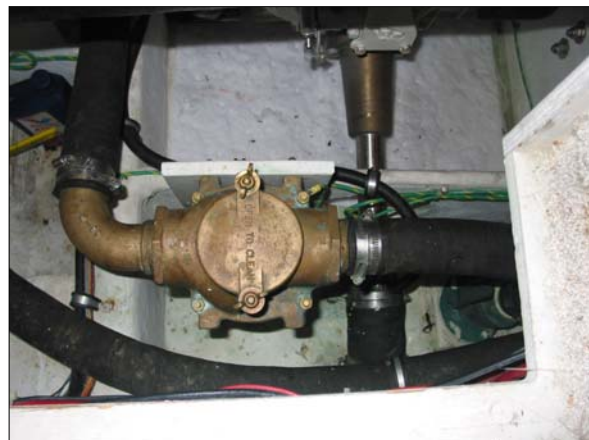
The stuffing boxes were secure.

Intake strainer, coupling and stuffing box

The propeller shafts were free of corrosion.

The shaft couplings were free of corrosion. The coupling nuts were secure. Set screws and keys retained the propeller shafts and were secured with seizing wire. No excessive dripping was observed.

Recommendation: *Have the propeller shaft/engine alignment checked by a qualified marine mechanic prior to extended use of the engine. This should be done when the vessel is in the water and water and fuel tanks are filled to their normal level.**

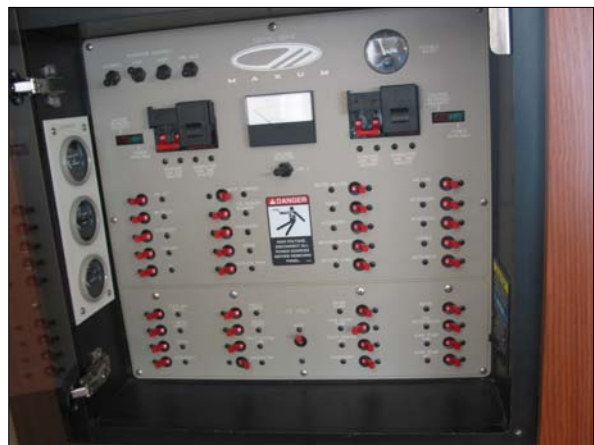
AC/DC power distribution panel

The power distribution panel was installed in the main saloon and was equipped with breakers, Volt meter, reverse polarity indicators and transfer switches between shore power and generator.
