## SAMPLE Report of Appraisal

1982 Pearson 303  
named

Appraisal performed for  
Mr. XXXXXXXXXXXX  
XXXXXXXXXX  
XXXXXXXXXX  
Date of report: June 20, 2003

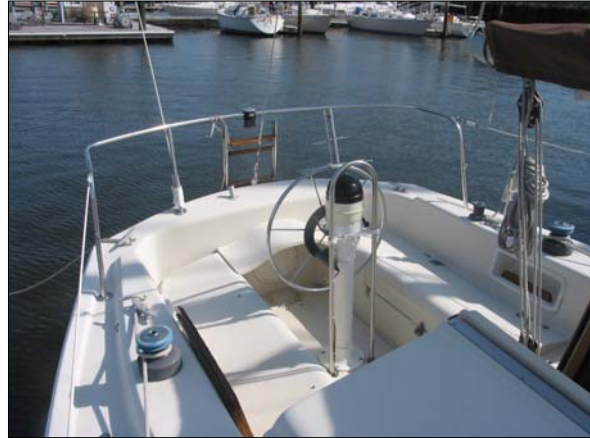
Cockpit

Moisture meter readings of topsides and deck were randomly taken with at clean and dry locations were generally low, except at the bow around the forward ventilation cowl, to starboard near the diagonal bracing of the second stanchion from forward and at the guard rail base in the cockpit.

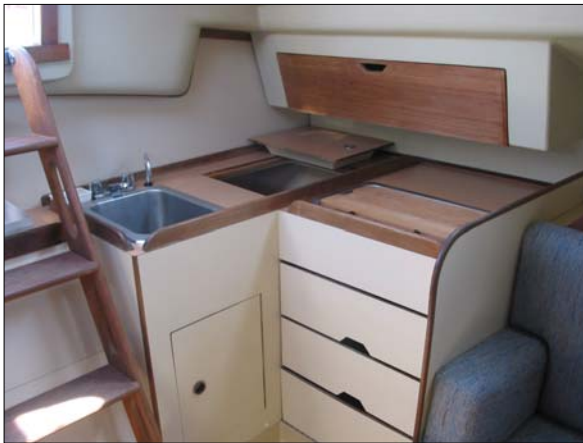
Galley

The interior was in better than average condition.

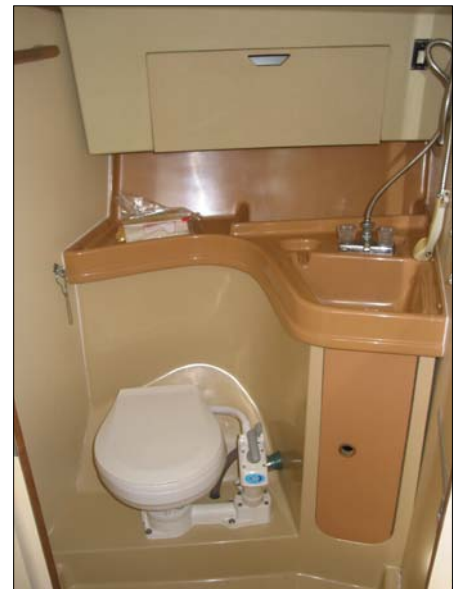
Head Compartment

Aft of the forward cabin was the head compartment to starboard. It was made of a one-piece FRP molding and contained a head, vanity with hot and cold water faucets and a hand shower. The head was a recently installed new Jabsco manual toilet

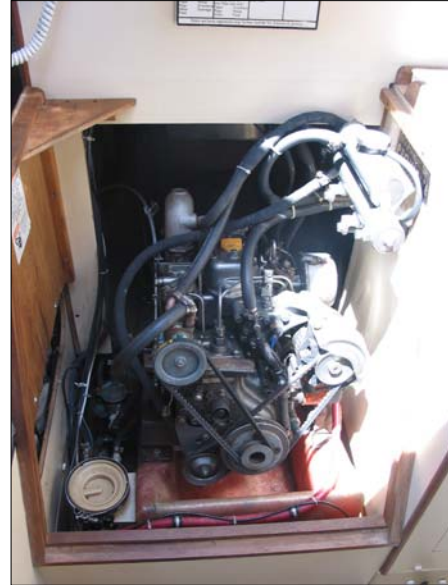
Yanmar diesel engine

The diesel engine was located behind and under the companionway. It was visually inspected only. Steel and rubber mounts were supported by substantial FRP stringers, which were securely attached to the hull. The mounts were rusty. Hoses and clamps appeared to be original, but remained serviceable.

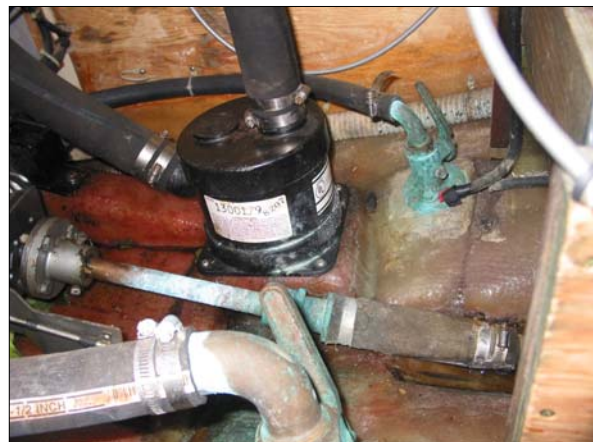
Exhaust muffler, stuffing box, coupling, seacocks

The coupling was secure. The shaft log hose was double clamped at the shaft log, but single clamped at the inboard end.

The exhaust hoses were in good condition. No signs of leaks were observed.

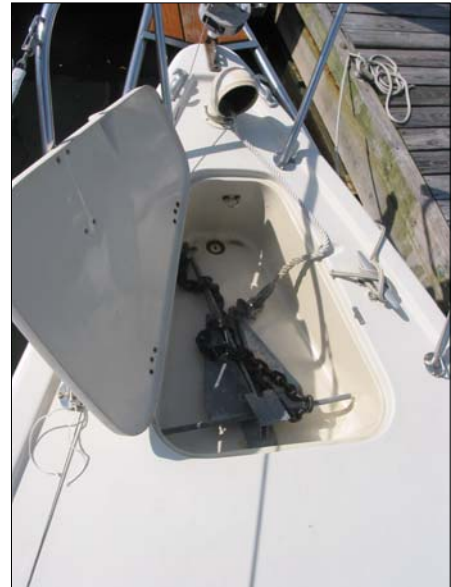
**Anchor in anchor well**

The vessel was equipped with an after- market anchor platform, constructed of stainless steel pipes. It was secure. The chain lead was rusty but serviceable. The nylon rode, as seen, was serviceable.

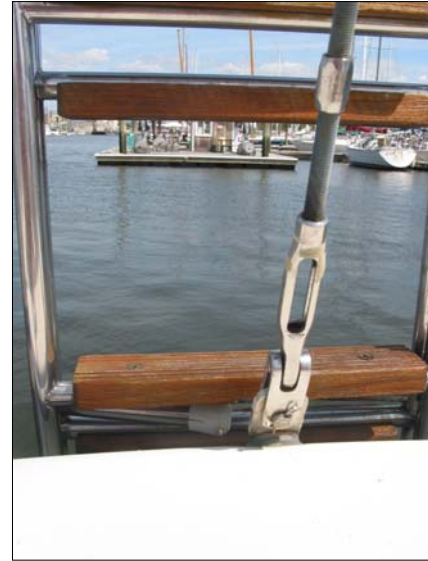
**Turnbuckle back stay**

The standing rigging appeared to be in good condition.  
were inspected. No evidence of cracks was found in the lower swages, turnbuckles or toggles  
The threaded studs of the turnbuckles of the aft stay were at their ends in the turnbuckle's body, leaving no room for cotter pins.
