# Muntz Marine Surveyors, LLC

## Condition and Valuation Report

**2006 Hydra-Sports Vector 2500 CC**  
(no name)

**Effective Date: October 24, 2011**  
**Date of Report: October 25, 2011**

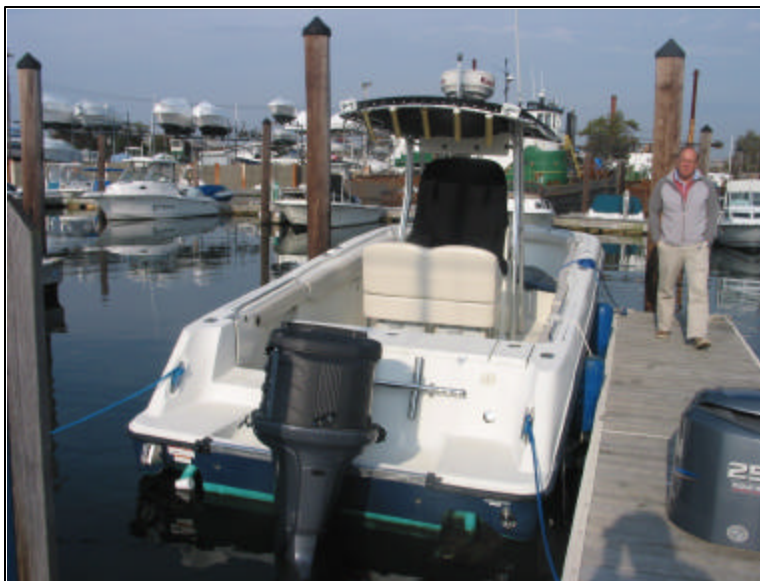
The through-hull and sea cocks of raw water intakes could not be inspected since the access hatch at the transom could not be opened.

All visible hoses were in good condition as seen.

**Recommendation:** *Get access to the through-hulls by opening the access hatch in the transom and check if sea cocks are operable and that hoses are double clamped.\*\**

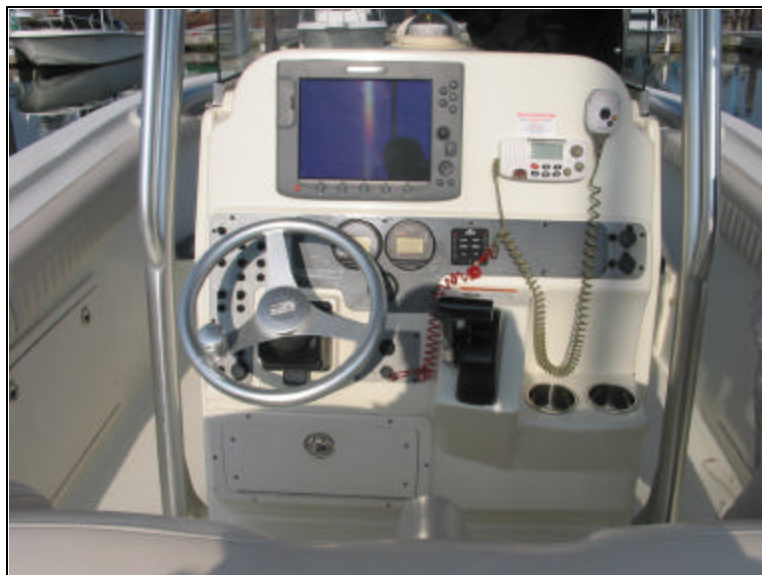
**Navigation instruments:** Ritchie spherical magnetic compass, Raymarine E 120 chartplotter/ radar/ fish finder (with 4 kW radome), Raymarine Ray 54 VHF

The navigation instruments were functioning.

The upholstery was in good condition.

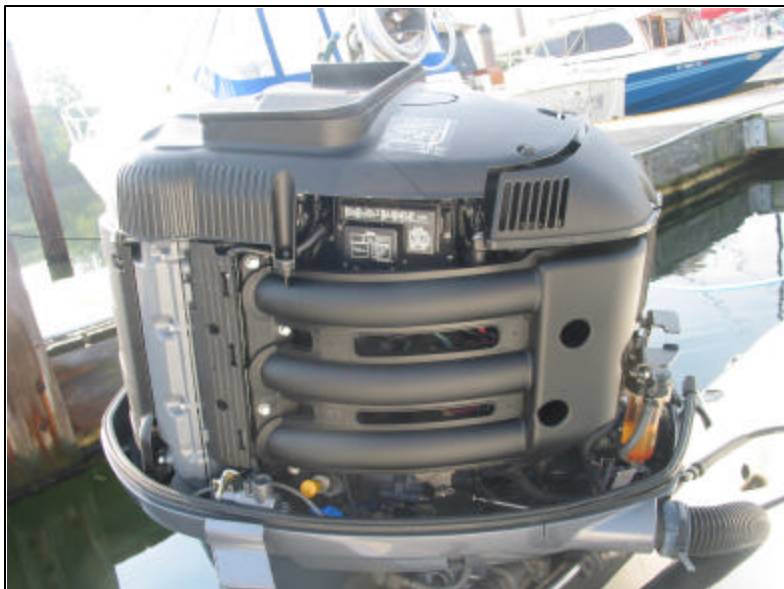
The power head and lower unit were in good cosmetic condition.

The propeller was in good condition.

The anode underneath the anti-ventilation was missing.

**Recommendation:** *Replace the missing anode underneath the ventilation plate of the motor.\**
