## Marine Survey Report

2006 Pursuit 3370 Offshore  
named

“XXXXXX”

**Date of Report: April 4, 2011**

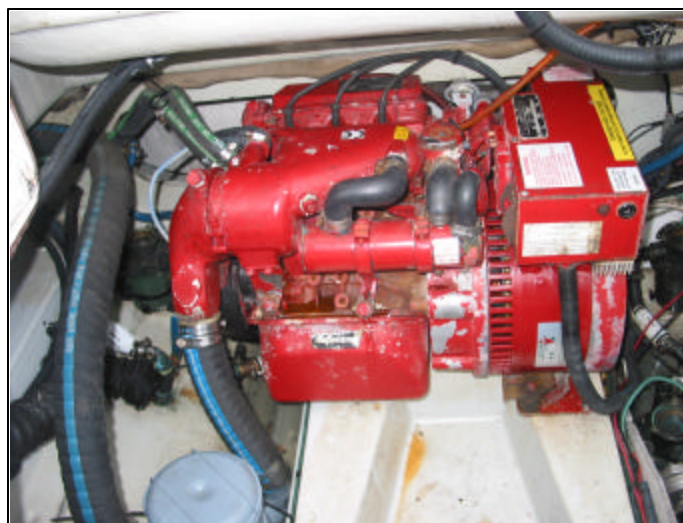
The genset showed some corrosion and flaking paint.

The Owner represented at the time of the survey that the engine was hunting and that a mechanic would investigate this further. Therefore the genset was not operated at the time of the survey.

**Recommendation:** *Investigate cause of hunting of the generator.\**

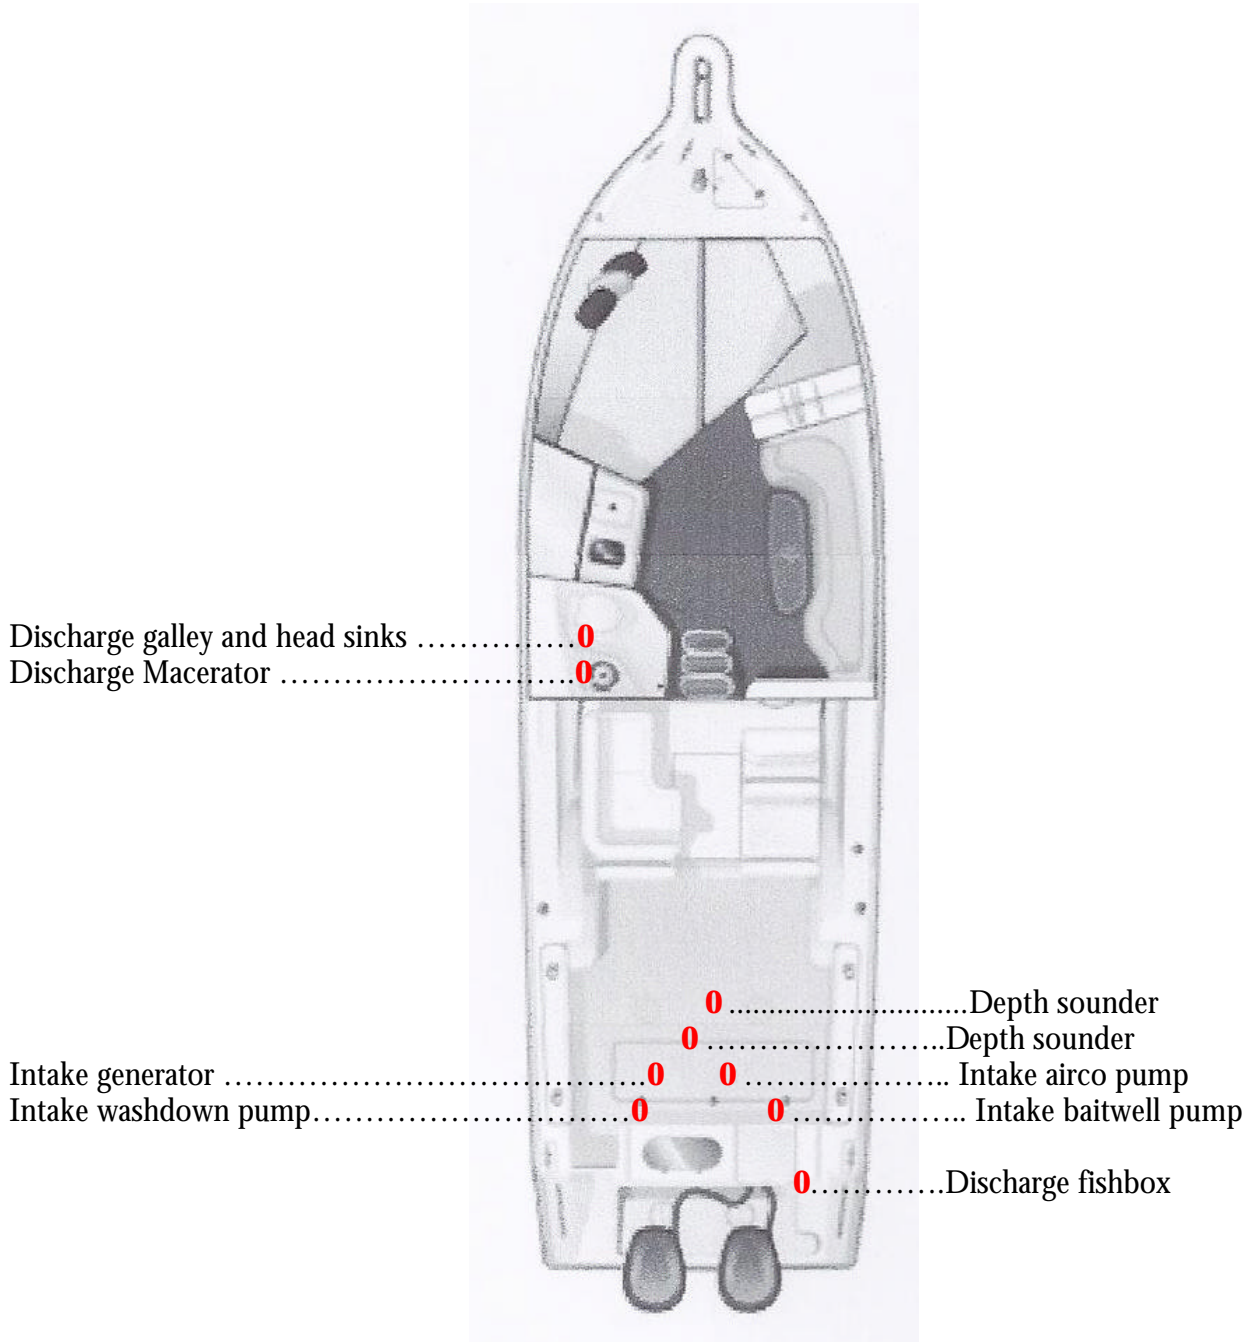
**Appendix D**  
**Schematic Location of Through-Hulls below Waterline**

Not all through-hulls may have been located due to limited access to the bilges and/or the inside of the hull.
