# Muntz Marine Surveyors, LLC

## Marine Survey Report

**1996 Tartan 4600**  
**named**

**Effective Date: October 28, 2011**

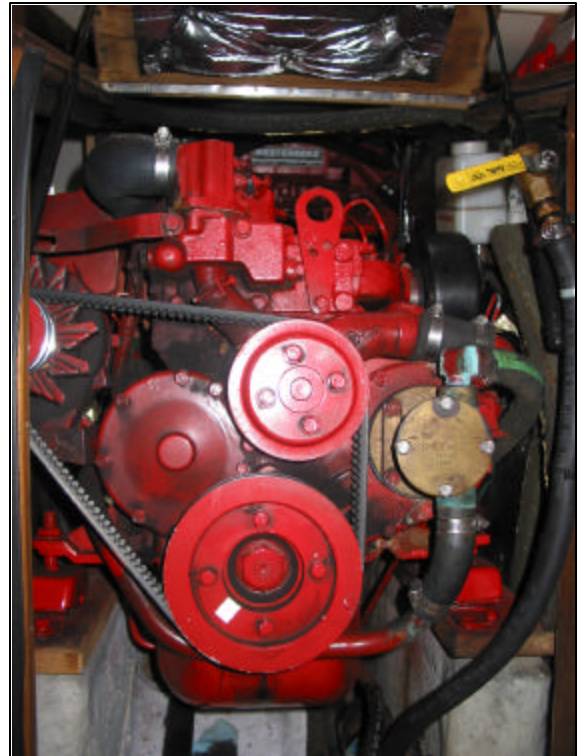
The engine was visually inspected only and no diagnostic analyses were made.

The engine was clean except for some belt dust and a small leak of the front seal cover.

**Recommendation:** *Clean up belt dust. If dust continues to be deposited, the pulley of the alternator should be realigned.\**

**Recommendation:** *Monitor the leakage of the propulsion engine front end seal.\**

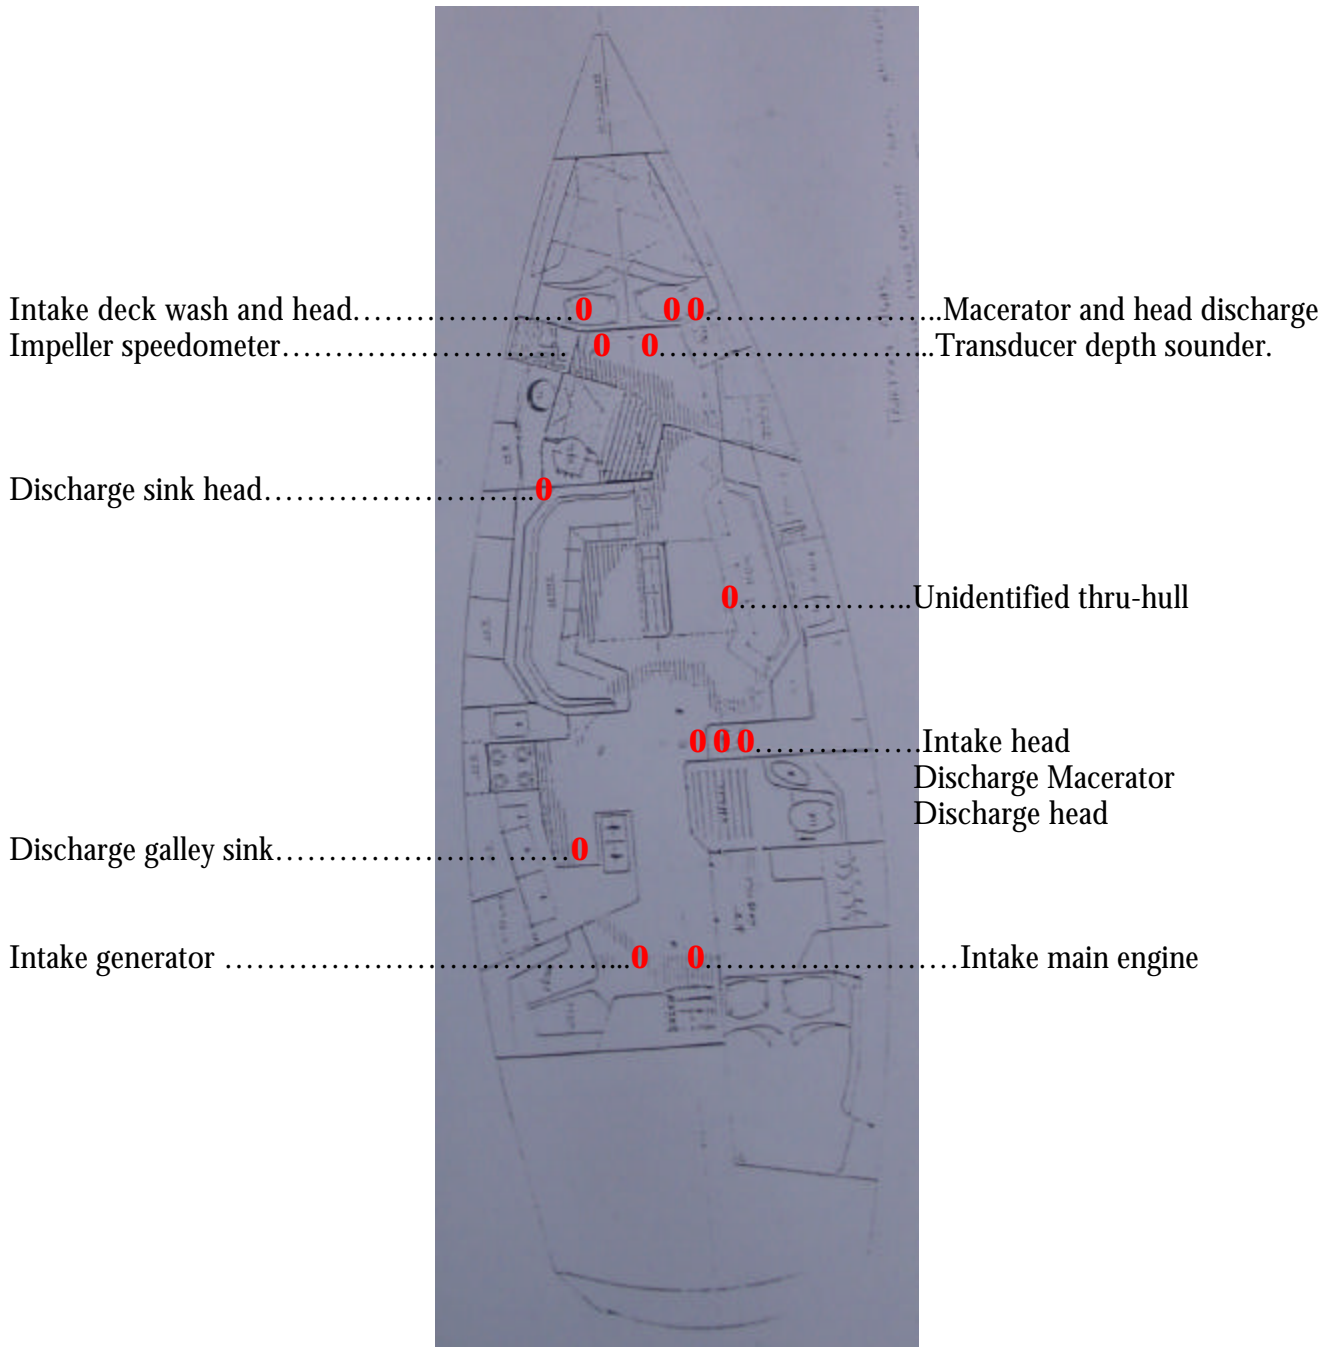
**Appendix E**  
**Schematic Location of Through-Hulls below Static Waterline**

Not all thru-hulls may have been located due to positioning of slings and limited access to the bilges and/or the inside of the hull.
