# Muntz Marine Surveyors, LLC

## Report of Appraisal 1978 Bristol 29.9 named

**Effective Date: May 20, 2011**

**Date of Report: May 22, 2011**

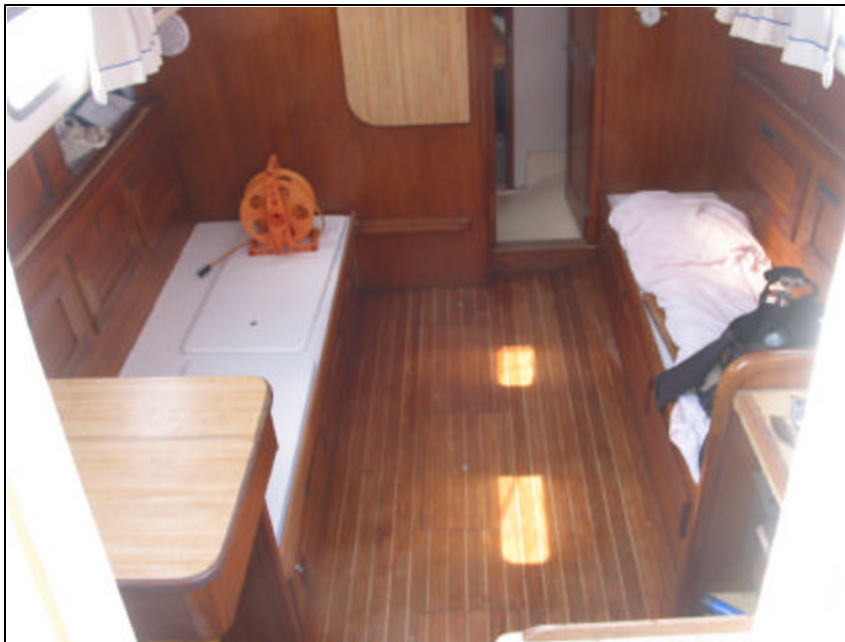
**Accommodation**

The interior was clean and well maintained.

The furniture and cabinetry were found in good repair.

No internal water leakages were observed.

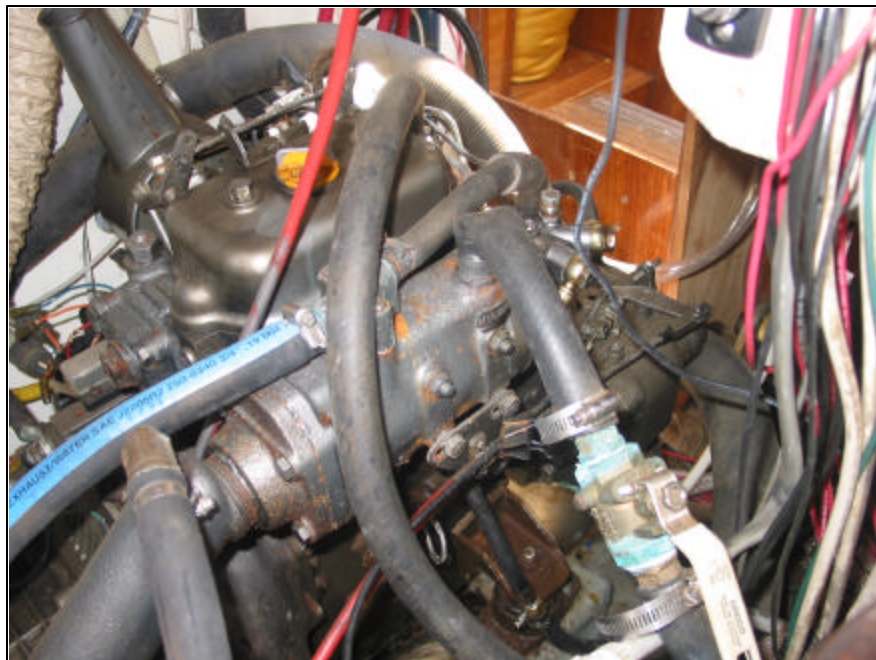
**Engine Yanmar 2 QM 15**

The engine was visually inspected only and no diagnostic analyses were made.  
The engine showed some corrosion.

Steel and rubber mounts were supported by molded FRP beds. The mounts showed some corrosion.  
The laminate engine bed was sounded where accessible and soundings were sharp and clear.  
Moisture meter readings were unremarkable.  
The bed appeared to be securely attached to the hull.

The exit of the raw cooling water into the exhaust elbow was not provided with a vented loop, which may cause sea water siphoning into the engine.
