Muntz Marine Surveyors

SAMPLE Marine Survey Report

1988 Grand Banks 32
named

Date of Report: May 11, 2006

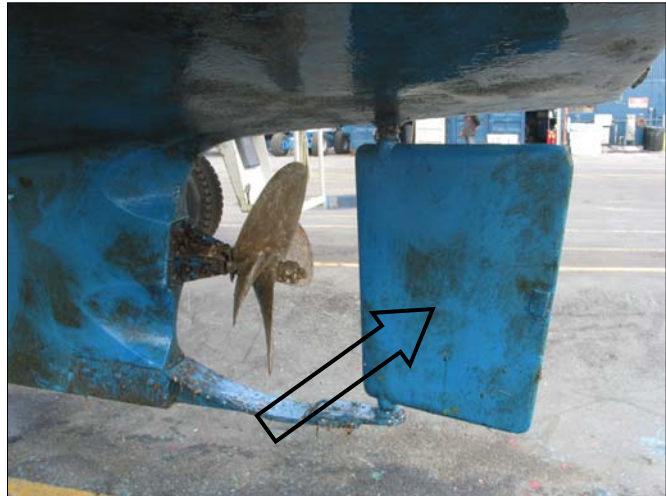
The exterior of the rudder was smooth and fair, but some weeping was noted from a pin hole to port.

Weeping pin hole rudder

Moisture meter readings were high, indicating that moisture had entered the rudder.

Recommendation: Seal pin hole in port side of rudder. Monitor the rudder for swelling and play between the rudder stock and rudder blade at each haul out. If this occurs, the FRP rudder blade should be opened up for inspection and repairs.*
