# Muntz Marine Surveyors

## SAMPLE Marine Survey Report

1988 Grand Banks 32  
named

Date of Report: May 11, 2006

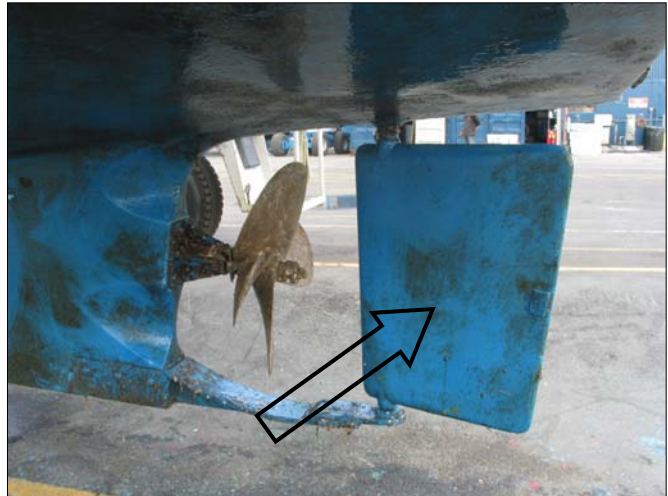
The exterior of the rudder was smooth and fair, but some weeping was noted from a pin hole to port.

**Weeping pin hole rudder**

Moisture meter readings were high, indicating that moisture had entered the rudder.

***Recommendation:*** Seal pin hole in port side of rudder. Monitor the rudder for swelling and play between the rudder stock and rudder blade at each haul out. If this occurs, the FRP rudder blade should be opened up for inspection and repairs.\*

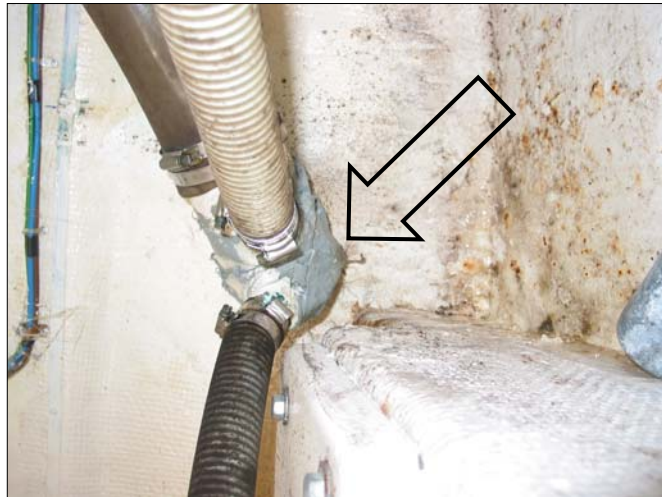
The cockpit drains were clamped to logs at the transom just above the waterline. Crude repairs were made to the logs with putty. The log to port was leaking. Since failure of the hose connections to the log would flood the vessel, the putty should be removed and proper repairs should be made.

**Log port cockpit drain with putty repairs**

**Recommendation:** *Repair both logs of cockpit drains as found necessary.\*\**
