# Muntz Marine Surveyors

## SAMPLE Condition and Valuation Report

1993 Beneteau Oceanis 510  
named

Date of Report: April 5, 2006

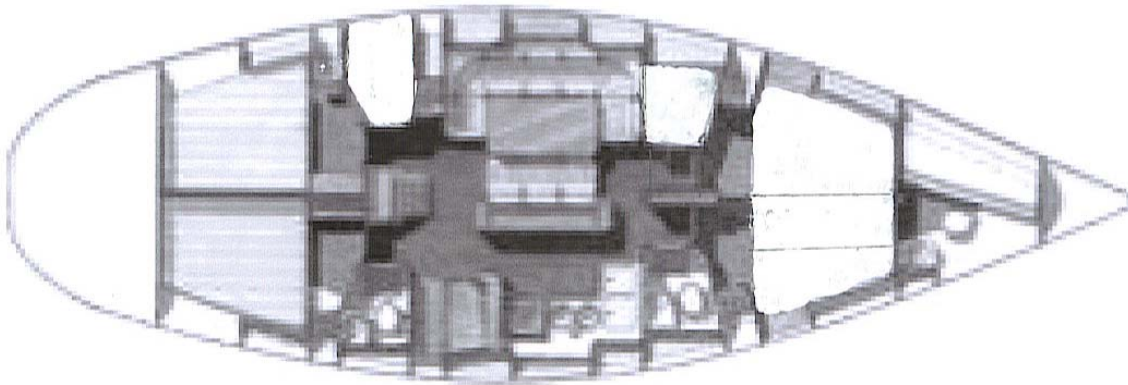
The layout of "XXXXXXXX" was different from her near-sister ships in that there was one large cabin forward and two of the four head compartments were in use as storage lockers. The layout is shown below:

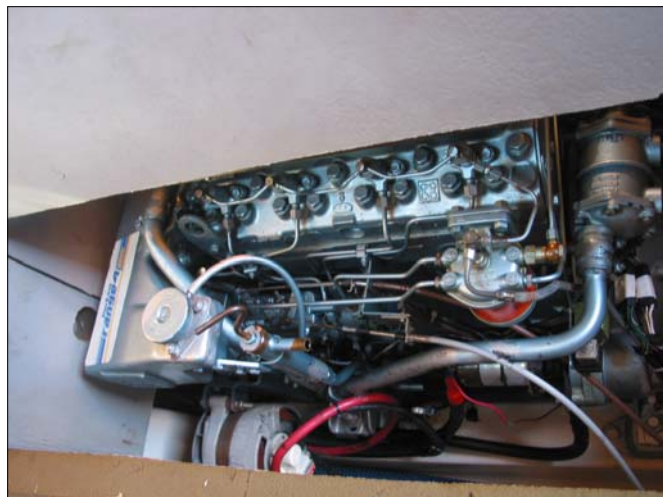
**Location:** under settee and island in the main saloon
