Muntz Marine Surveyors

SAMPLE Marine Survey Report

1988 Grand Banks 32
named

Date of Report: May 11, 2006

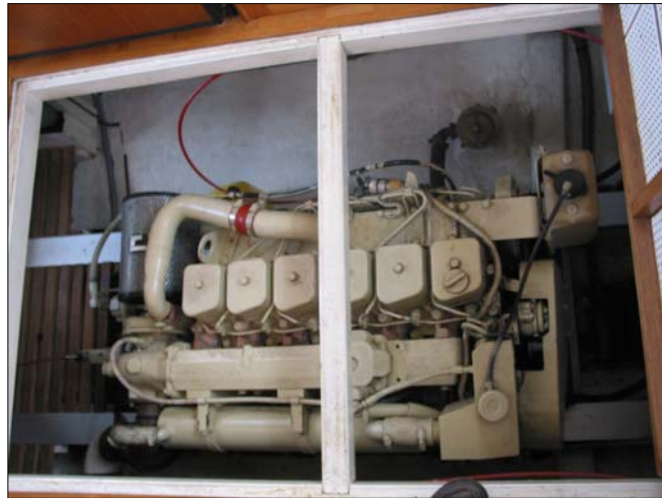
The engines and their installation were visually inspected only; no diagnostic analyses were made. The engine and engine compartment were found clean.
