# Muntz Marine Surveyors

## SAMPLE Marine Survey Report

1988 Grand Banks 32  
named

Date of Report: May 11, 2006

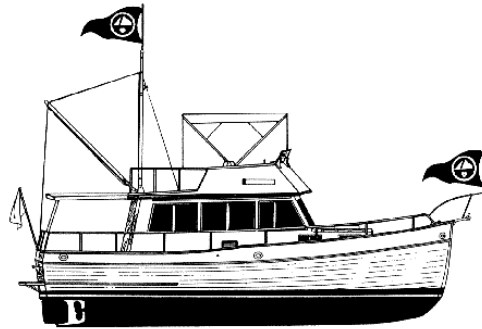
Documented vessels must have their official number, preceded by the abbreviation "NO.", marked in block-type Arabic numerals not less than three inches in height on some clearly visible interior structural part of the hull. The number must be permanently affixed to the vessel so that alteration,

removal or replacement would be obvious. It may be on a separate plate fastened in such a manner that its removal normally would cause some scarring of or damage to the surrounding hull area. The name and hailing port must also be displayed.

**Recommendation:** *Provide vessel with official number and hailing port as per 46 CFR 67.121 and 67.123.\*\*\**
